Manhole Inspection Summary

Manhole # **S11KK_017MH**

Insp Date: **1/21/09 10:20 AM**

Location Address: **3113 WINDSOR AVE** Cross Street: **N ROSEDALE AVE**

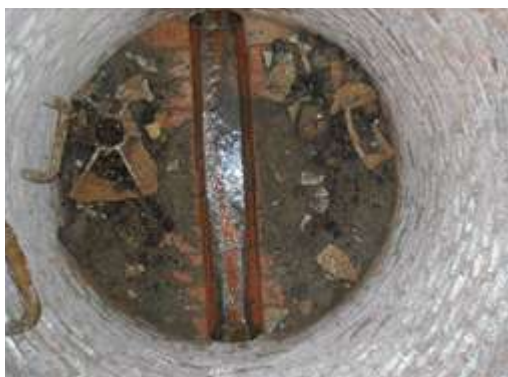
Top View

NOTE FRAGMENTS FROM A PREVIOUS MANHOLE LID EXISTING IN BARREL

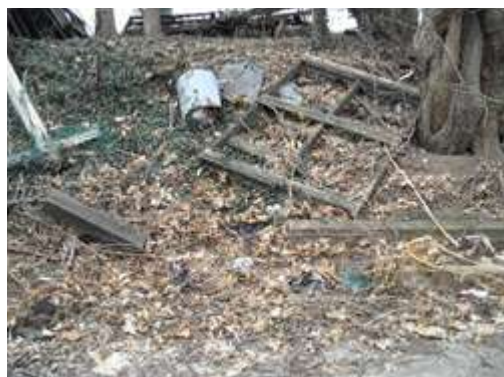
LOCATION PRIOR TO EXPOSING

HILLSIDE PRIOR TO MH EXCAVATION

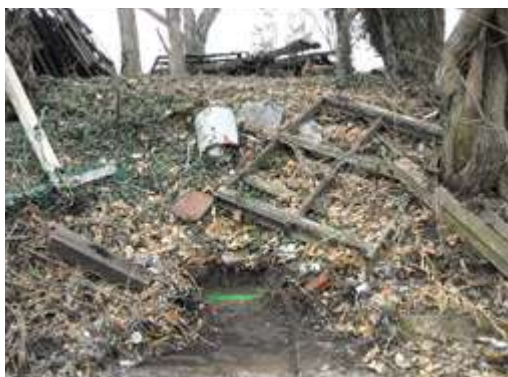
EXPOSED MH

MANHOLE EXPOSED IN GROUND

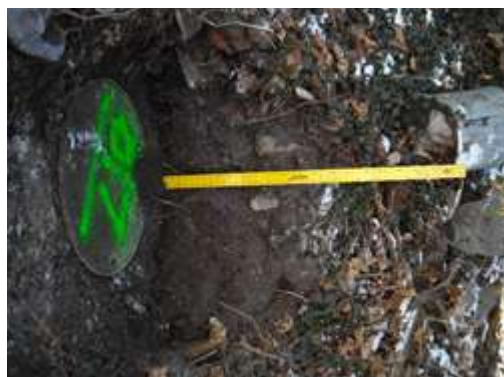
REAR OF MANHOLE LID IS 30" BELOW GRADE

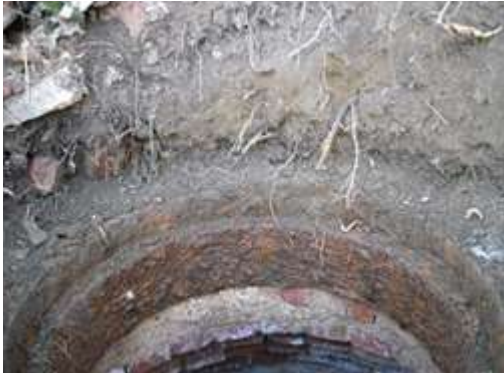
Defect 1

EVIDENCE OF INFLOW - WAS
BURRIED, STILL IN HILLSIDE

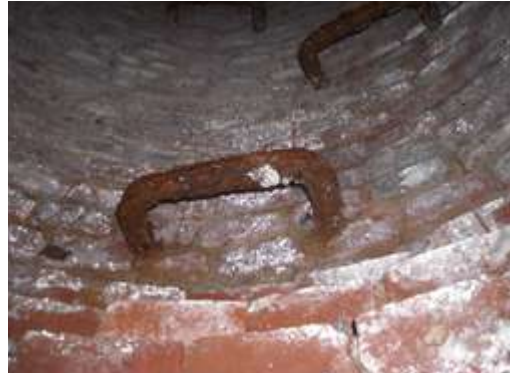
Defect 3

Steps Count: **3** Missing: **0** ☒ **Corroded**

CORRODED STEPS

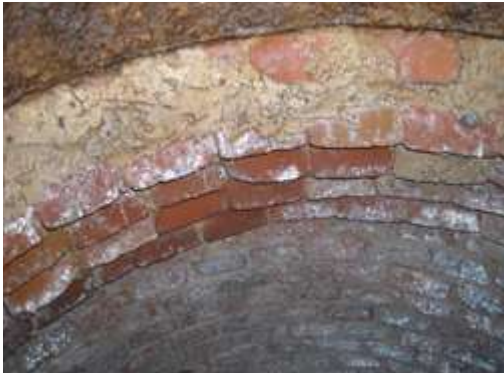
Defect 2

Chimney / Frame Adjustment ☒ Exists Material: **Brick and Concrete** ☒ Parged Height: **14** (in.)
Condition: ☒ Sound ☐ Cracked ☐ Root Intrusion ☐ Loose Brick ☐ Deteriorated
Infiltration: ☒ None ☐ Joint ☐ Cracks ☐ Mortar ☐ Roots ☐ Wall

14" CHIMNEY ADJUSTMENT

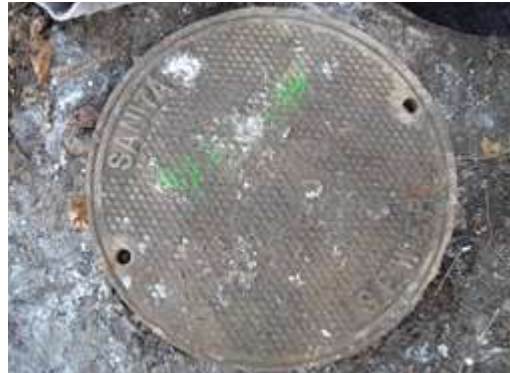
Defect 4

Cover Shape: **Circular** Diameter: **24** (in.) Length: (in.) Dist A/B Grade: **-12** (in.)
Type: **Sanitary** Condition: **Cracked** Cover Material: **Cast Iron**
Properties: ☐ Bolted ☒ Vented ☐ Water Tight ☐ Water Tight Insert

CRACKED LID

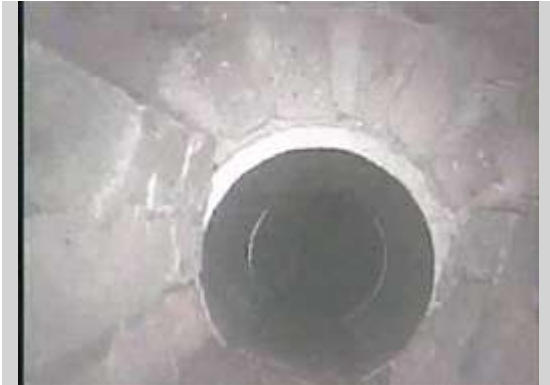
12 O'Clock Outflow

10 in. Circular Gravity Sewer
Pipe Out @ 12 O'Clock

Pipe Height: **9.6** (in.) Rod and Bar (Angled)
Pipe Material: **Clay** ☐ Pipe Lined
Invert Depth: **7.18** (ft.) Flow Characteristics: **Slow**
Deposits: ☒ None ☐ Mud ☐ Sludge ☐ Debris ☐ Grease
Silt Depth: (in.) Deposits Extent:
Infiltration: **None** Pipe Seal Cond: **Sound**

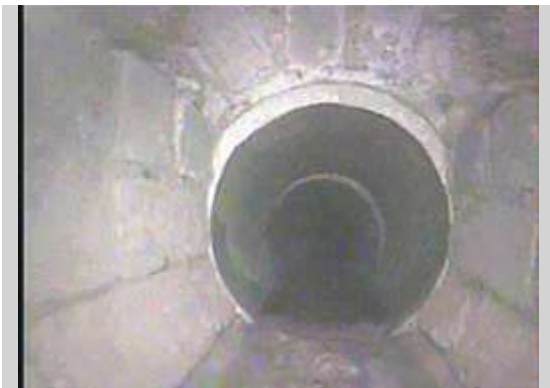
6 O'Clock Inflow

10 in. Circular Gravity Sewer
Pipe In @ 6 O'Clock

Pipe Height: **9.6** (in.) Rod and Bar (Angled)
Pipe Material: **Clay** ☐ Pipe Lined
Invert Depth: **7.27** (ft.) Flow Characteristics: **Slow**
Deposits: ☒ None ☐ Mud ☐ Sludge ☐ Debris ☐ Grease
Silt Depth: (in.) Deposits Extent:
Infiltration: **None** Pipe Seal Cond: **Sound**
